THOSE DAMN ZENITH STROMBERGS

*[By John H. Twist
of University Motors](#)*

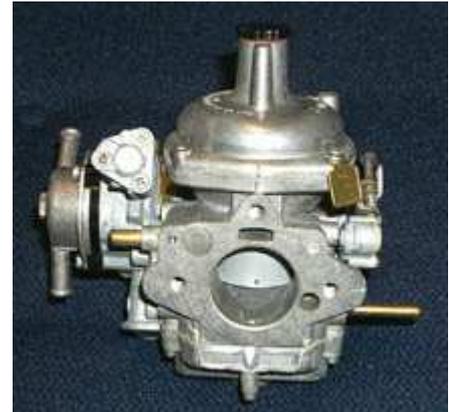
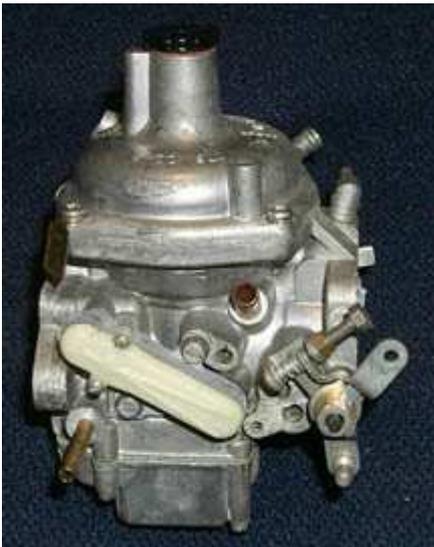
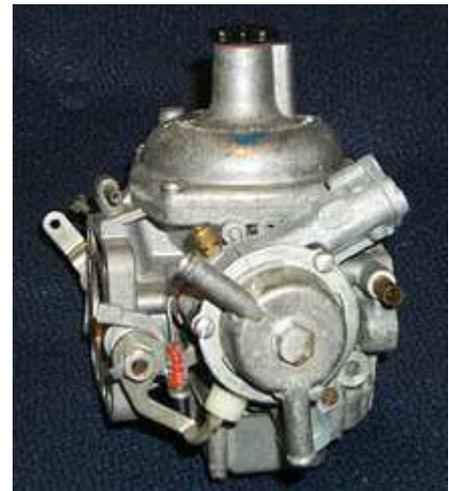
The carb illustrated is a
slightly modified version
from that of the MGB, but
will give you a good idea of
how things are put together.
